## Water Trustee Report

August 10<sup>th</sup>, 2021

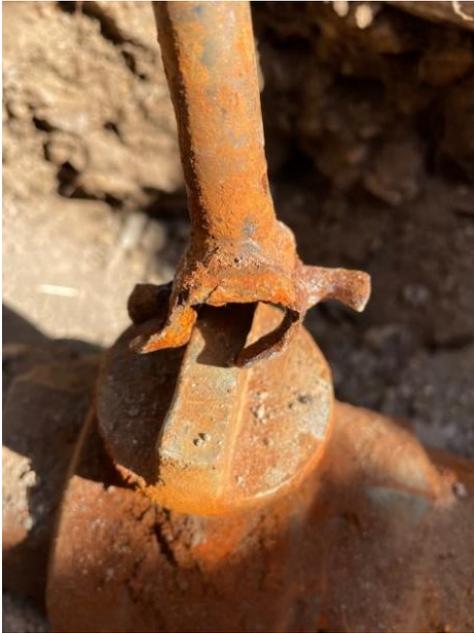
Extension metal bar that key was opening  
Disimilar metals corroded connection

The latest casualty is the Standpipe at the Fire Hall. Thanks to the help of Barry T, Gary G, and Colin R we were able to determine that the Tee Head was compromised and no longer turned ¼ turn to the on position. Fortunately, it broke in the off position.

We received some good information from Bob Crooks and Robert Noble on what type of parts were installed. We were able to remove a metal cover and stem to determine cause of break down. It appears there are several factors, which range from using dissimilar metals, inadequate stem to Turn tee, incorrect key used to turn tee off and on and rusting of pipes.

This standpipe is critical for the Fire Department, and it is imperative we complete this repair or replacement as quickly as possible. The standpipe was installed in 1993.

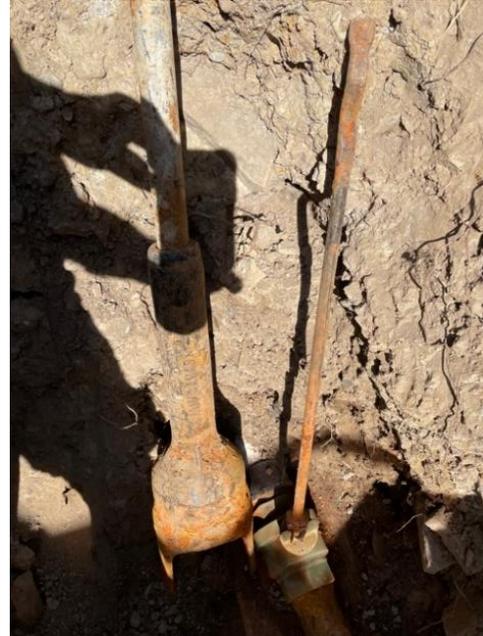
Metal shroud over Gate Valve. Metal  
extension fit inside tube and corroded.
